No. 1484668.7

SAMPLE DESCRIPTION:
Flooring planks – 15mm Engineered hardwood flooring assembly (with Selleys Aquadhere Exterior D3 rate PVA glue applied in the joints) fixed to a 3mm Acrylic transparent base using Selleys timber glue: Oak Nature-OT10255-15mm.

ISO 4760:2022(E) - LAMINATE FLOORING – TOPICAL MOISTURE RESISTANCE – ASSEMBLED JOINT (MODIFIED)

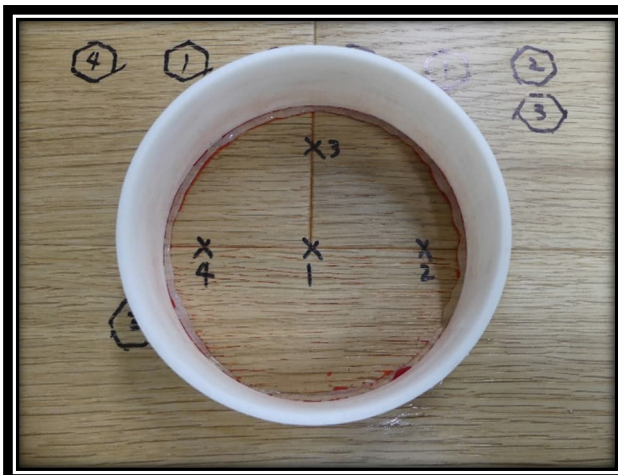
Recovered Swell

Quantitative measurements are used to calculate surface swell in mm (within 15 minutes after water removal) and recovery swell (24 hours after removal of water).
